**ACCIDENT INVESTIGATION BOARD**

**FINAL REPORT ON AIRCRAFT ACCIDENT**

**THE ACCIDENT OF HOT AIR BALLOON KUBICEK BB 120P TYPE  
HAVING REGISTRATION NUMBER TC-BGJ**

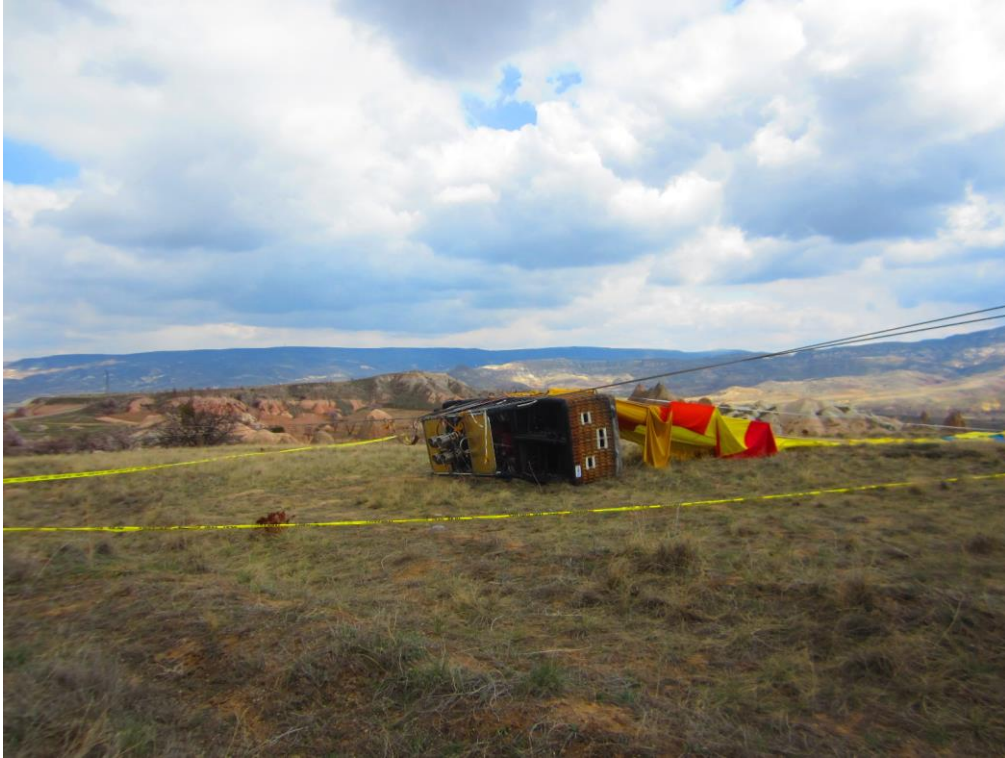
**Picture-1: Accident Location**

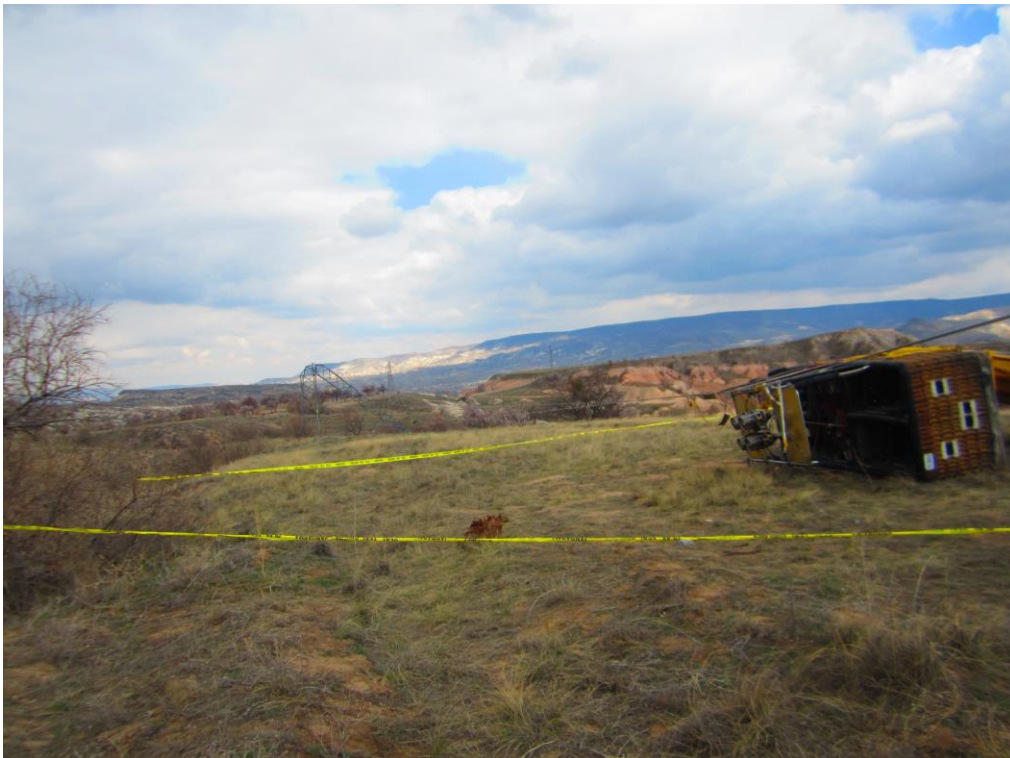
**Picture-2: Accident Location**

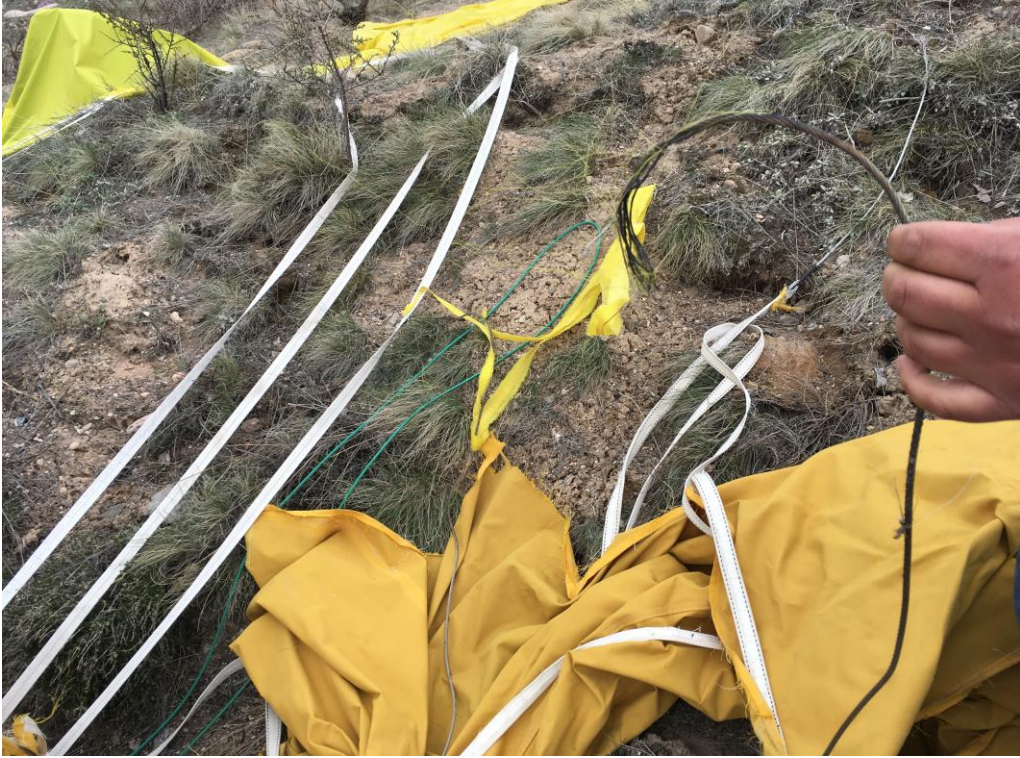
2. A part of envelope load tapes broke off during the touch on energy line, remaining undamaged tapes were cut in order to detach from energy line.
3. Upper side of basket got burnt pursuant to touch on energy line.

**Picture-3:** Envelope Load Tapes Damage

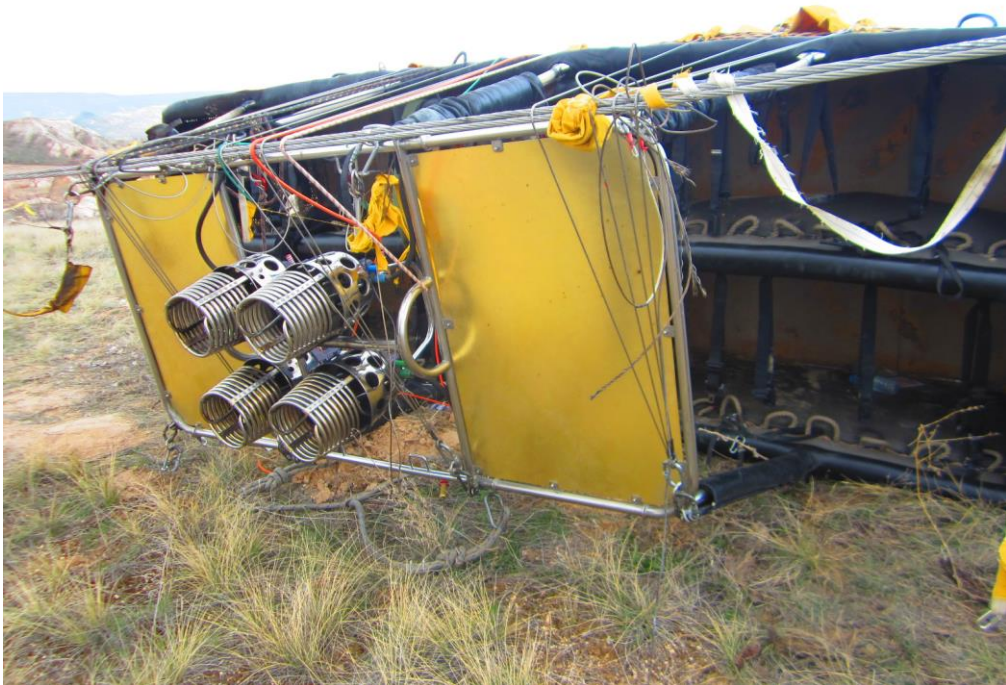
4. Basket load tapes broke off after touch on energy line.
5. In burner frame, arc and tarnish formations were found as a result of energy line contact.

**Picture-4:** Load Tapes Damage

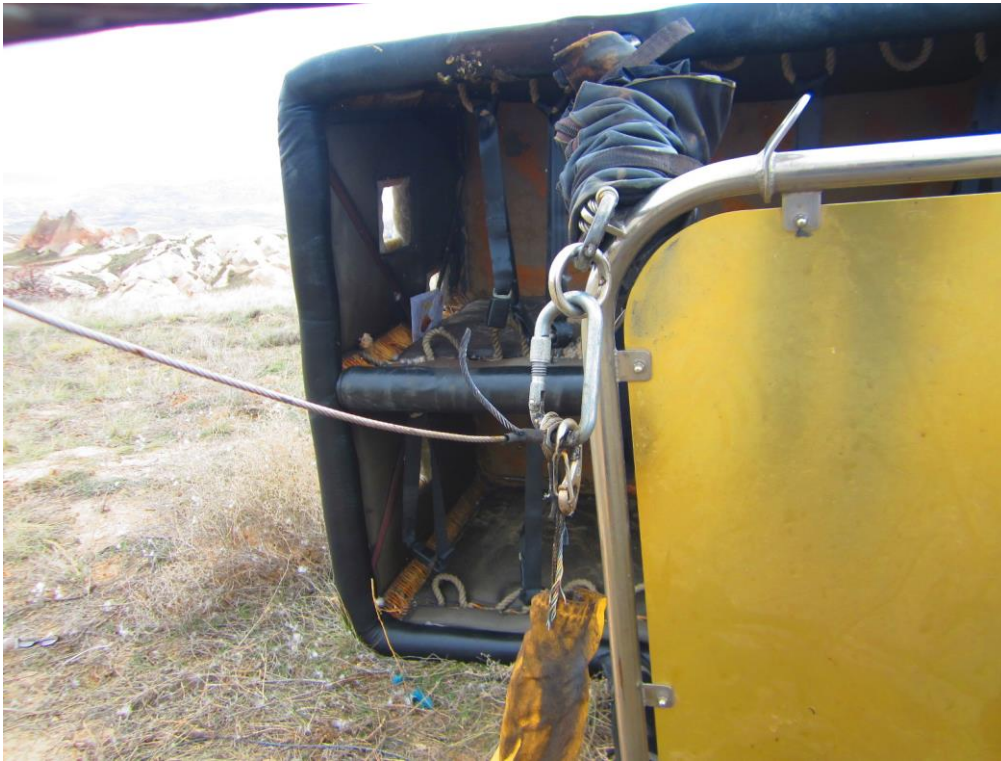
**Picture-5:** Basket Upper Side Damage

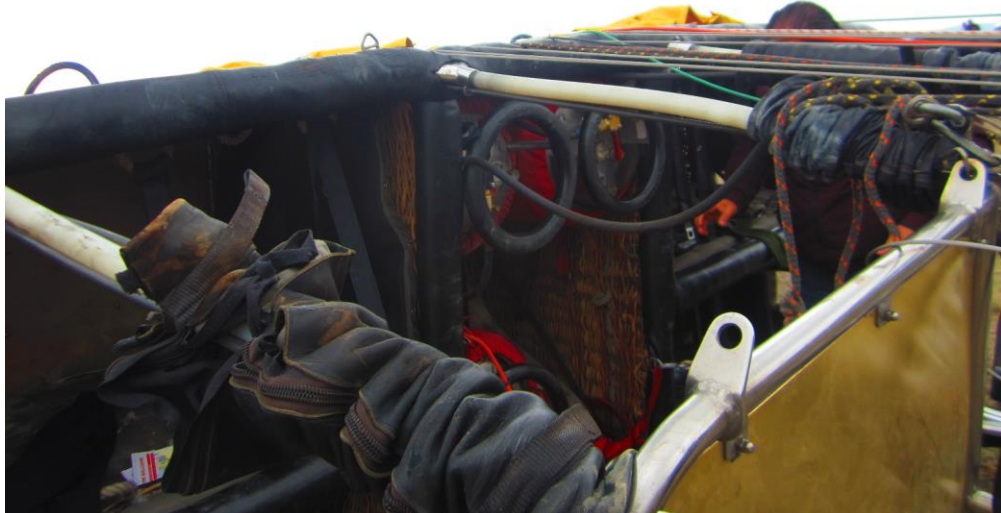
**Picture-6:** Burner Frame Housing Damage

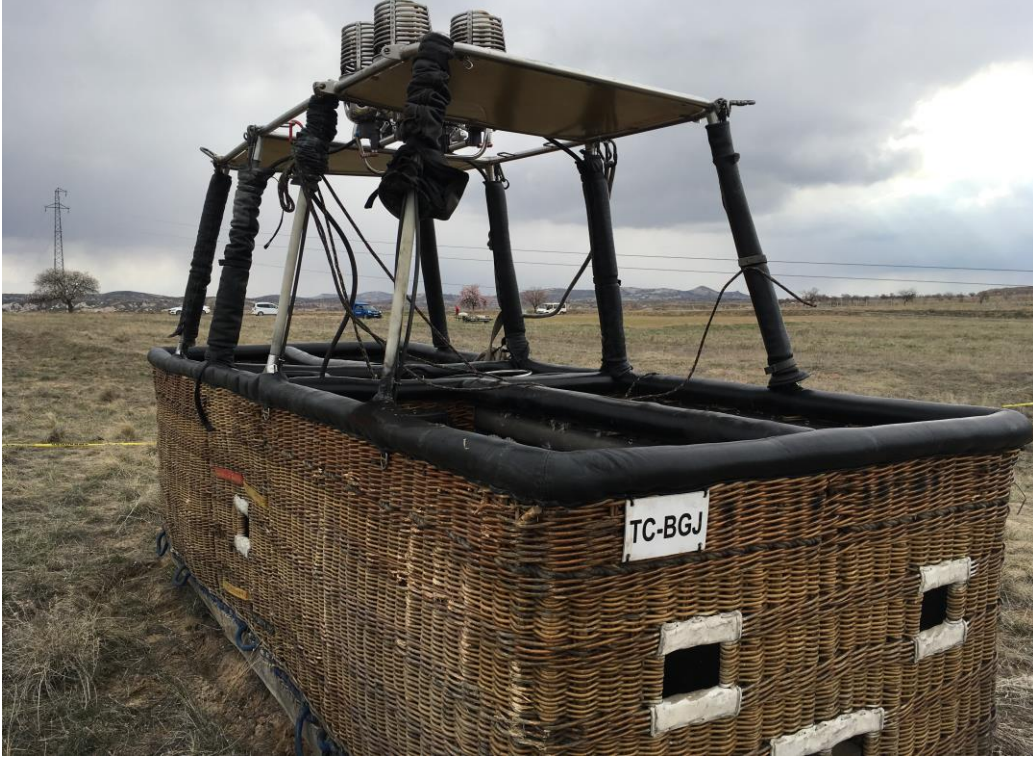
6. In upper basket frame, arc and tarnish formations were found as a result of energy line contact.
7. In wicker parts and bamboo parts of the basket, breakages were observed as a result of energy line contact and hitting the ground.

**Picture-7:** Basket Damage

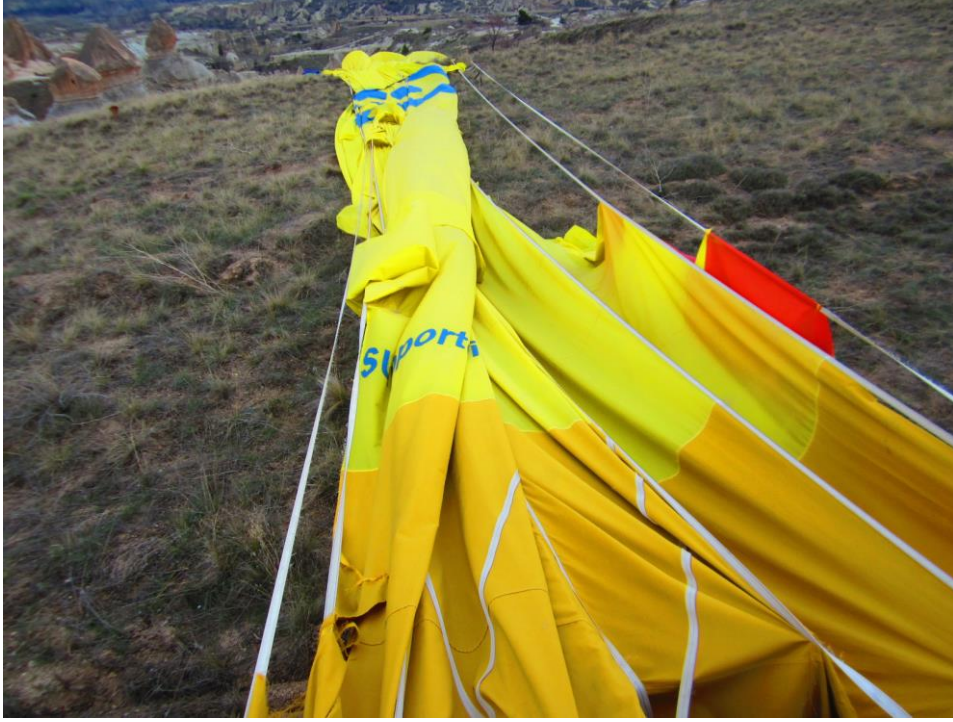
During touristic trip, on 09.04.2017 at 03:46:21 UTC the Kubicek BB120P type hot air balloon having registration number TC-BGJ whose owner and operator is Goremme Balloon, went down with 1 pilot and 20 passengers, 15 meters from ground, as a result of striking energy line of MEDAŞ in the vicinity of Nevşehir Province, Ürgüp District, Karakuş, Üzençi Location, and the skirt of the balloon closed because of the pressure caused by wind and loading tapes, and the pressurized air smashed the envelope.

**Picture-5: Smashed Balloon**

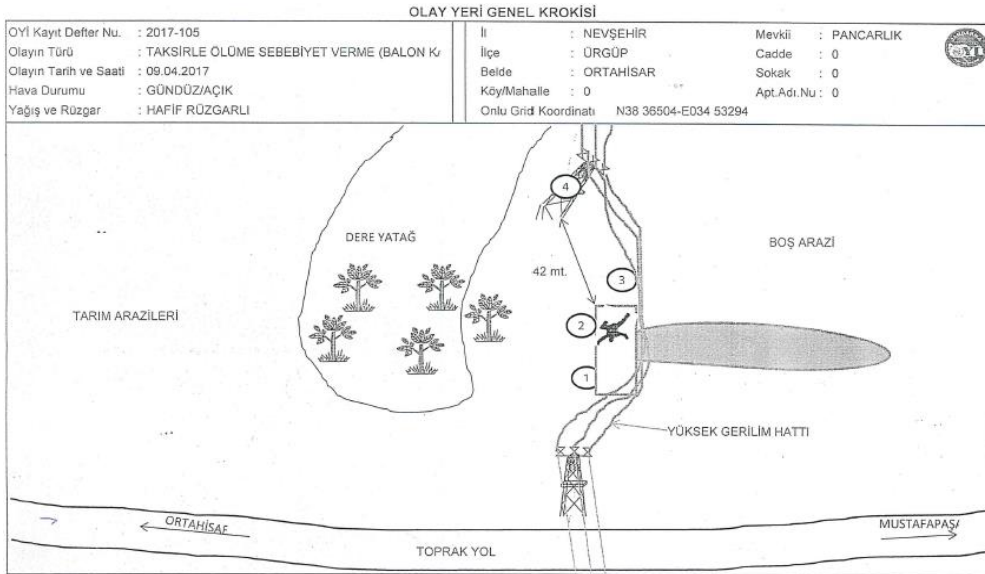
**Sketch-3: General Sketch of Accident Scene prepared by Gendarme**

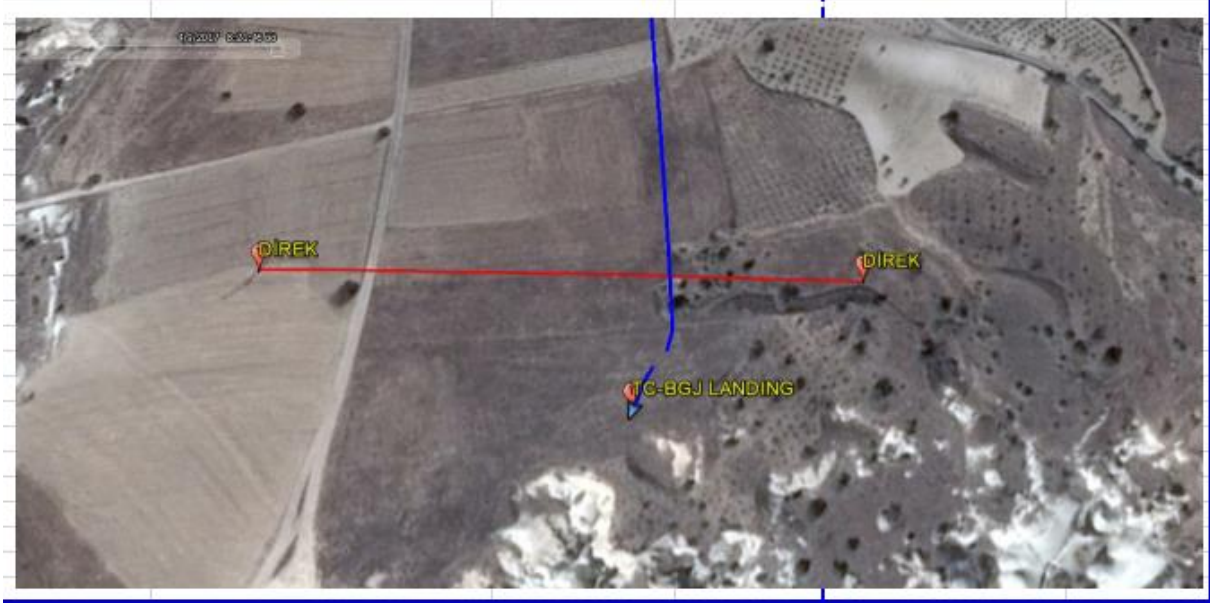
**Sketch-4:** Accident Location

*Note:* Direk means electricity mast.
