AIR ACCIDENTS  
INVESTIGATION INSTITUTE  
Beranových 130  
199 00 Prague 9 – Letňany

# FINAL REPORT

**of a serious incident  
of the sailplane K7 – Rhönadler,  
registration OK-9132,  
in the ATZ of Slaný Airport  
on 8 September 2024**

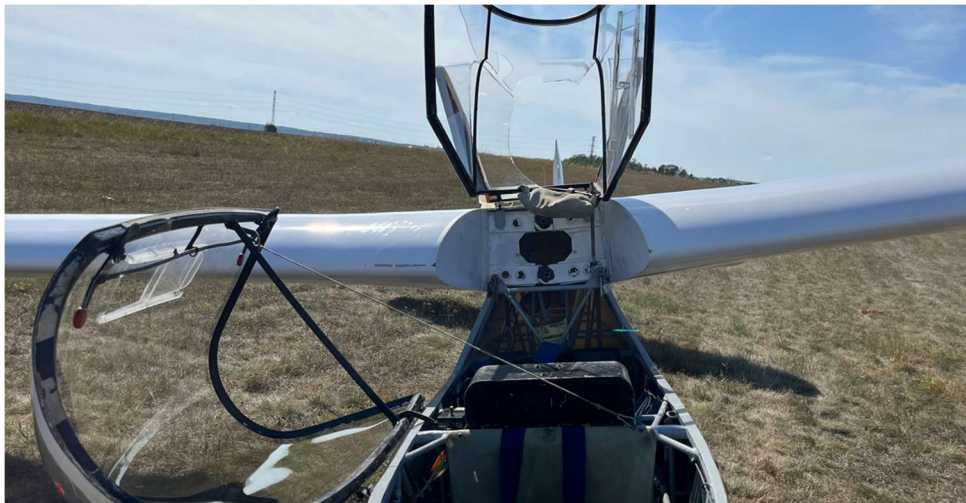
The sailplane was found to have a minor damage – a broken rear canopy. The seat belts on the student pilot's seat were found unfastened and were not damaged.

Fig. 1 – Damaged rear sailplane canopy

The rear canopy was opened and damaged immediately after opening of the front canopy.

The rear canopy was damaged. The seat belts on the front seat were unfastened and undamaged.

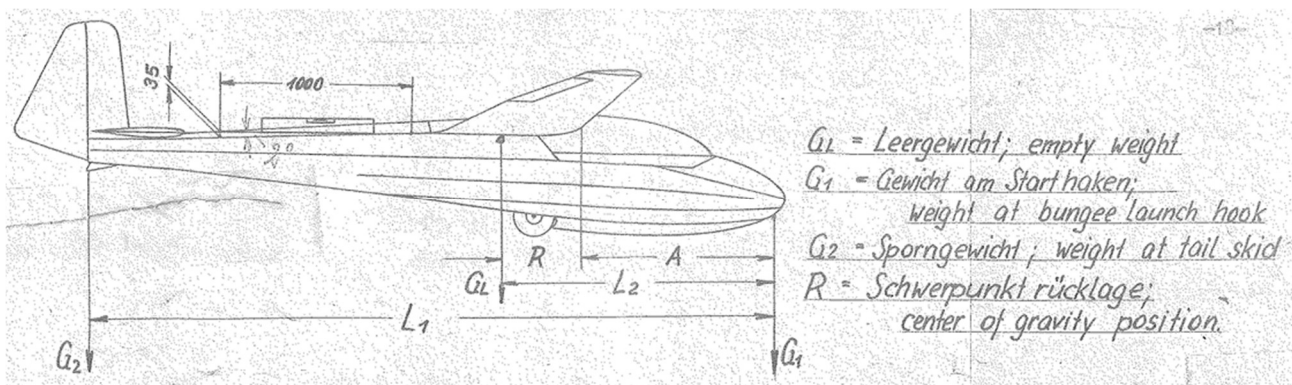
Fig. 2 – Schematic diagram for calculating the centre-of-gravity position (Flight Manual)

According to the Flight Manual, the centre of gravity (C.G.) position could be between 492.5 mm and 592.5 mm from the reference point with an empty weight of 323 kg. The position of the centre of gravity found during the weighing of the empty sailplane was 486.1 mm beyond the reference point with a tolerance of +/-50 mm and was within the limits of the Flight Manual.

The position of the centre of gravity was calculated to be 390.12 mm beyond the reference point, hence 115.12 mm beyond the rear limit.

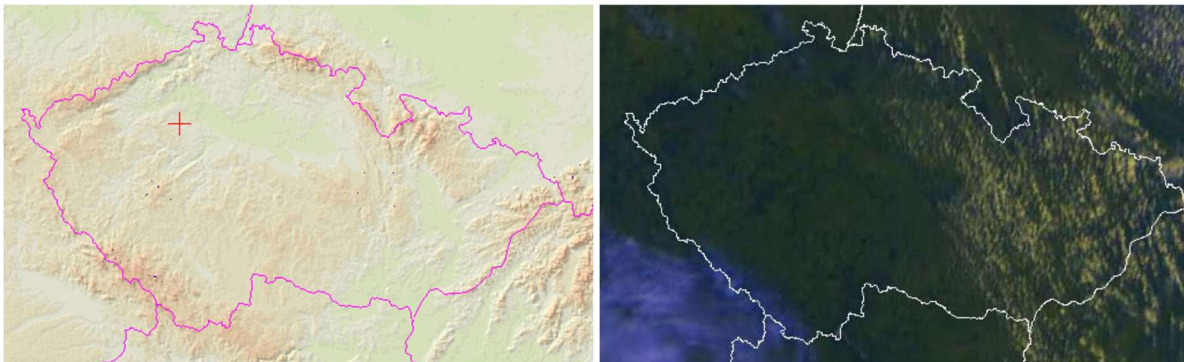
In the area of the incident during the sailplane's flight from Slaný Airport, there was probably a variable (easterly to southeasterly) wind with a speed of  $2-3 \text{ m}\cdot\text{s}^{-1}$ . The visibility was above 10 km, the sky was almost clear with an isolated high Ci type cloud. There were no precipitation or other weather phenomena. The temperature was  $25-27^\circ\text{C}$ .

Fig. 3 – Satellite images of the meteorological situation

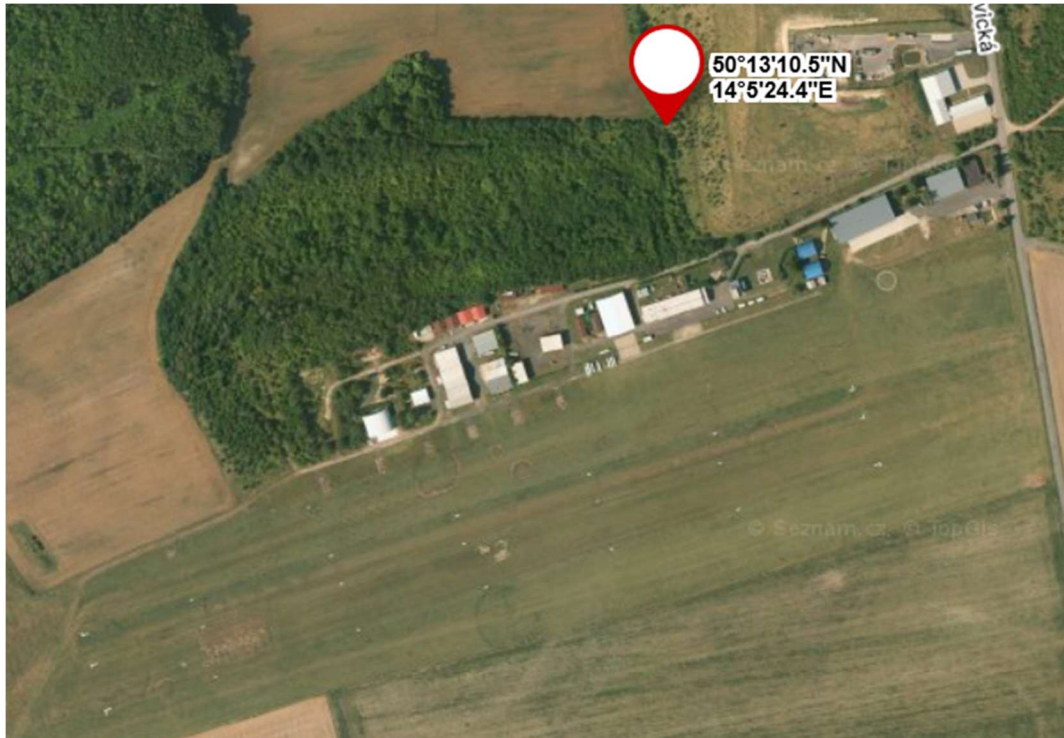
The place of impact of the student pilot's body was in a forest near a field, about 350 m NNE of the airport reference point of Slaný Airport. Impact coordinates: 50°13'10.5"N 14°05'24.4"E.

Fig. 6 – Pilot student's impact location

The body of the student pilot was found about 350 m NNE of the airport reference point without any signs of life.

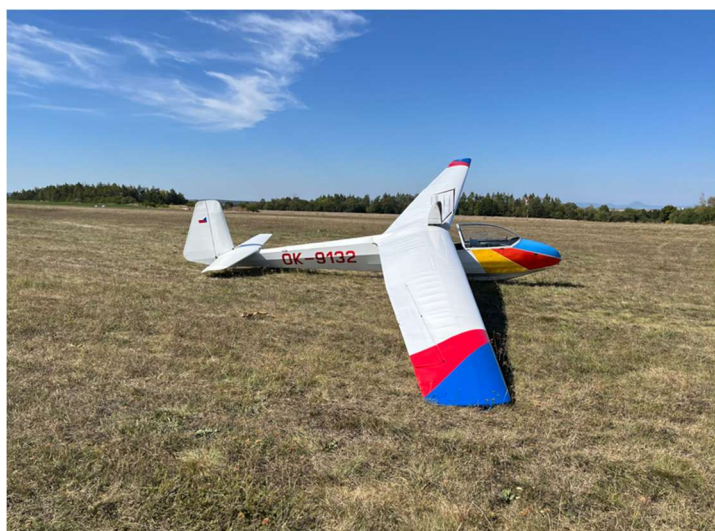
The instructor landed the sailplane safely within the first third of runway 07R. The sailplane had a damaged rear canopy.

Fig. 7 – Sailplane after landing at LKSN
